Manhole Inspection Summary

Manhole # S35C__045MH

Insp Date: 1/15/09 2:45 PM

Location Address: **301 st paul st**

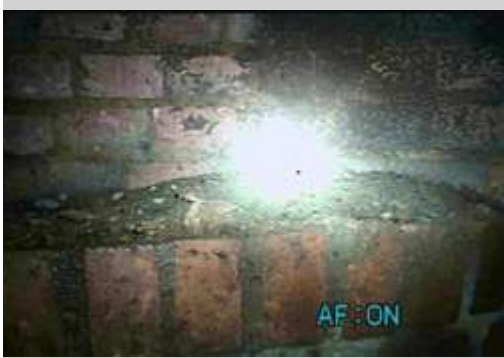
Defect 2

Condition: ☐ Sound ☐ Cracked ☐ Root Intrusion ☐ Deteriorated ☐ Leaks ☒ **Debris**

bench debris

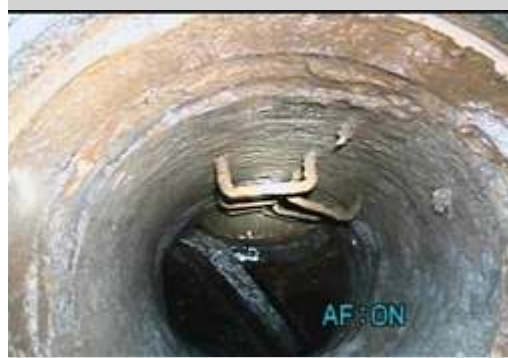
Defect 1

Count: **7** Missing: **1** ☒ **Corroded**

corr steps

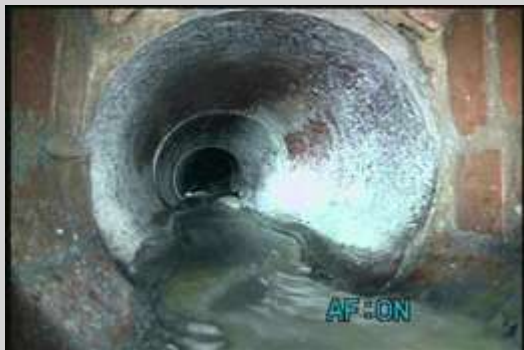
12 O'Clock Outflow

10 in. Circular Gravity Sewer
Pipe Out @ 12 O'Clock

Invert Depth: 12.75 (ft.) Flow Characteristics: Fast

Deposits: ☒ None ☐ Mud ☐ Sludge ☐ Debris ☐ Grease

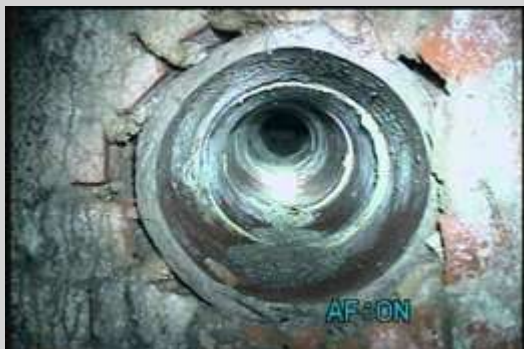
3 O'Clock Inflow

8 in. Circular Gravity Sewer
Pipe In @ 3 O'Clock

Invert Depth: 8.41 (ft.) Flow Characteristics: None

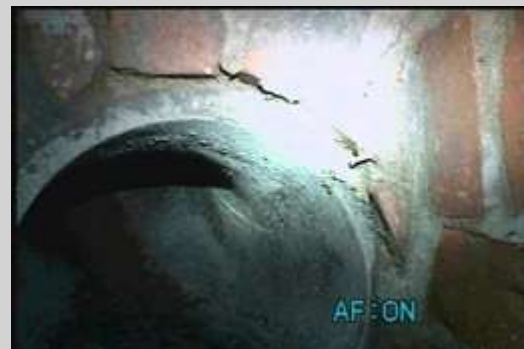
Drop In @ 3 O'Clock

Drop: Outside Direct

Drop Condition: Open

Connects To: Dead End

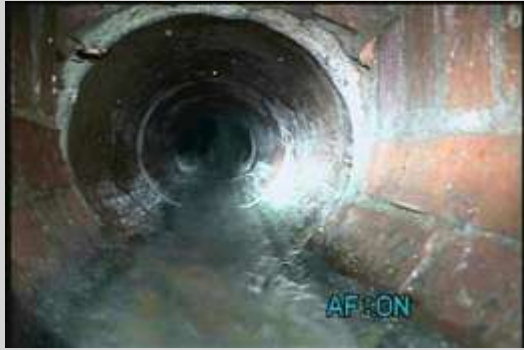
7 O'Clock Inflow

10 in. Circular Gravity Sewer
Pipe In @ 7 O'Clock

Invert Depth: **12.70** (ft.) Flow Characteristics: **Fast**
